INFO SHEET

Algae and Coatings

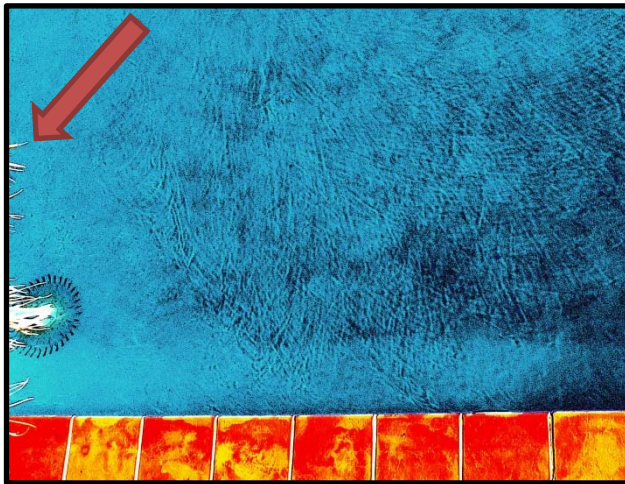
Here we can see “stains” moving away from the creepy crawler towards the right-hand corner where the surface is quite rough. The original pool surface area around the creepy crawler is quite smooth and thus clean as the coating is smooth also and follows the profile.

There is over hanging vegetation just visible on far left as well. (see arrow top left))

So, in this case the overhanging vegetation has led to it falling into the pool, rotting and in areas where the original concrete surface is rough, with hills and valleys, algae forming in the bottom of the valleys, highlighting them. Yet it looks like the coating is faulty.

Treatment is quite straightforward, remove all overhanging or nearby vegetation, including palm trees and resultant seeds and nuts. Then use a good algaecide (from pool shop), some brooming and vacuuming to remove residues.

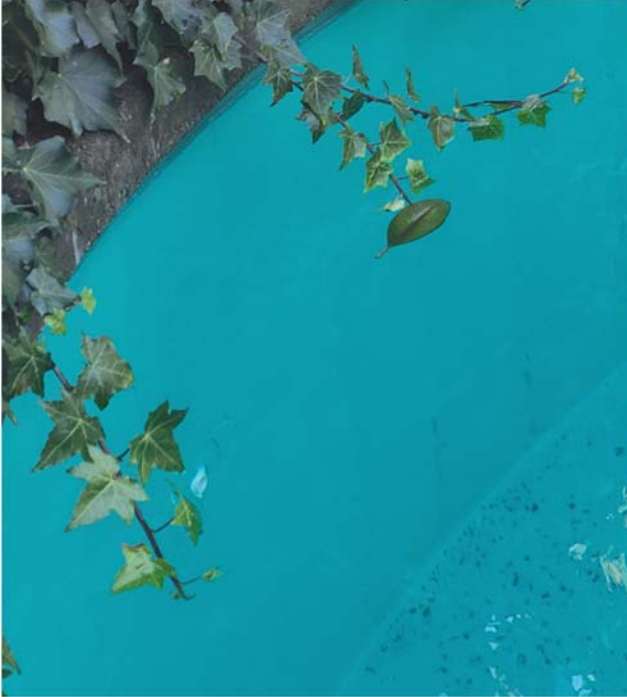
Over hanging Ivy creating algae on pool floor.

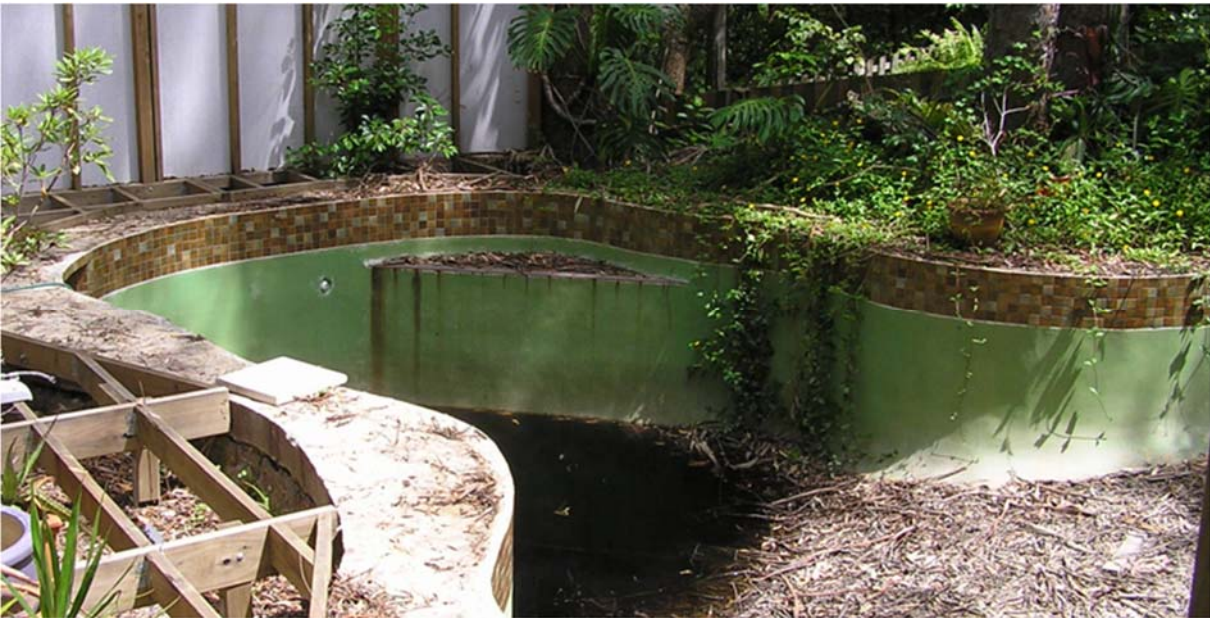
Or even to this level..
