INFO SHEET

Algae and Coatings

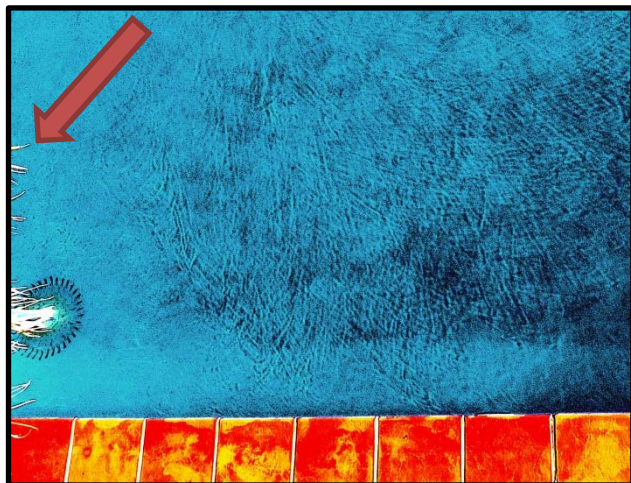
Here we can see “stains” moving away from the creepy crawler towards the right-hand corner where the surface is quite rough. The original pool surface area around the creepy crawler is quite smooth and thus clean as the coating is smooth also and follows the profile.

There is over hanging vegetation just visible on far left as well. (see arrow)

So in this case the overhanging vegetation has led to matter falling into the pool, rotting and in areas where the original concrete surface is rough, with hills and valleys, algae forming in the bottom of the valleys, highlighting them. Yet it looks like the coating is faulty.

Treatment is quite straightforward, remove all overhanging or nearby vegetation, including palm trees and resultant seeds and nuts. Then use a good algicide (from pool shop), some brooming and vacuuming to remove residues.
