INFO SHEET

Rust stains and pool resurfacing

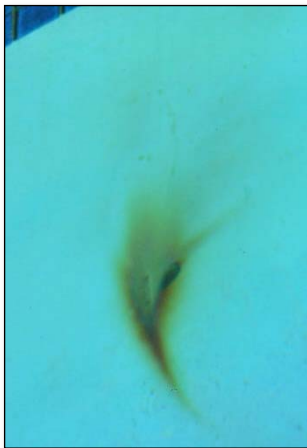
General Surface rust stains

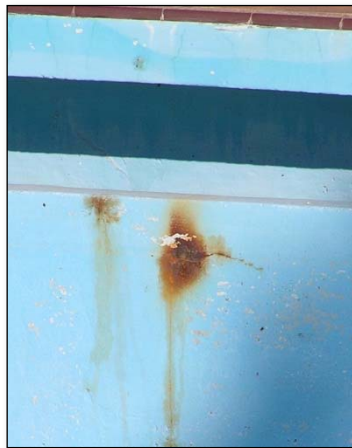
Crack with rust stains.

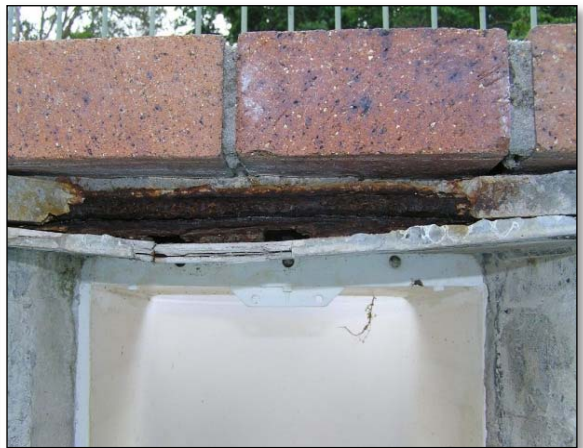
Check the metal plate above skimmer box

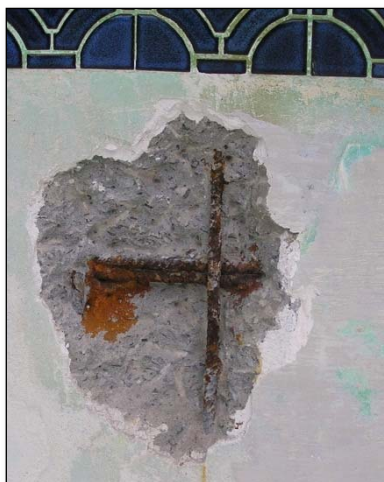
What you may see once you start digging into the rust spot. On closer inspection it can be seen that the rust is all around the steel and the concrete needs to be **dug out completely and rusty steel exposed on ALL sides. This is vital for a successful result.**
