INFO SHEET

PLUNGE POOLS and WATER INGRESS

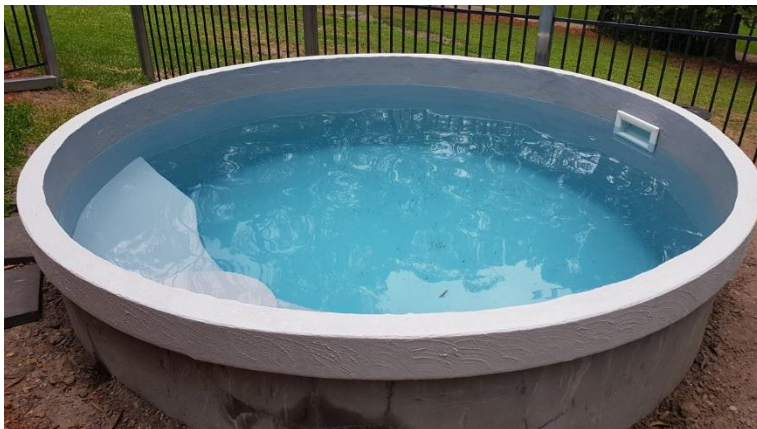
Fig 1: Typical concrete plunge pool. Cast concrete floor and plastered wired sides. Also note partially buried in the ground.

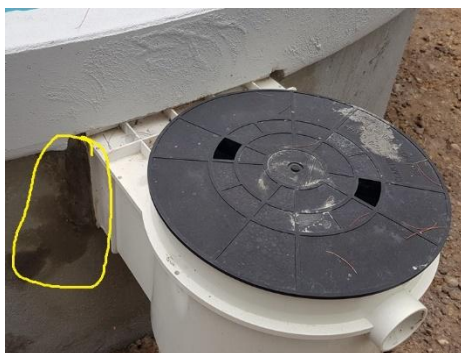
Fig 2: Cracks due to craning issues and also water seepage from the pool. **Note:** no waterproofing on outside. Wall thickness about 50 – 75 mm.

1. No waterproof membrane on outside of the pool or its base.
2. The plastered walls on mesh are thin (50 – 75 mm) and not waterproof.
3. The pool is partially buried into the ground, allowing ground moisture to enter concrete shell.
4. There is a thermal gradient between the lower areas and the top of the walls when in hot sun. This causes moisture to move upward in the walls, which acts like a wick.
5. Hydrostatic pressure is also at work, pushing moisture from within the walls, towards the water, on the inside.
6. As the coating is highly vapour impermeable the relative pressures and gradients are enough to create blisters, with moisture trapped inside the blister, till broken.

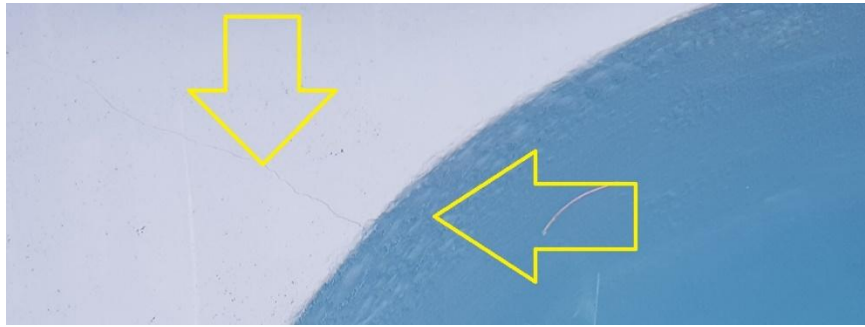
Fig 5: Structural crack on step inside and resulting blisters in the riser below.

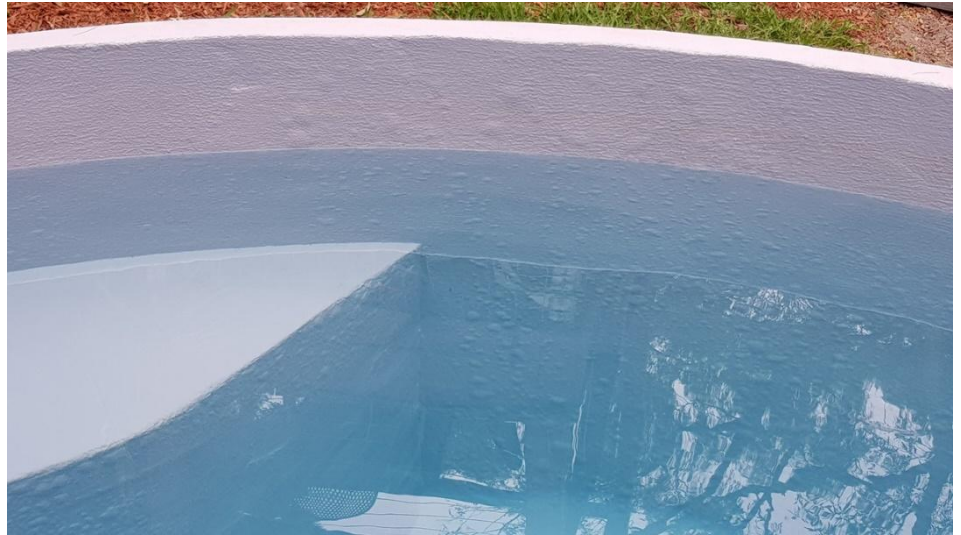
Fig 6: General view inside the plunge pool showing blisters above and below the water line. See discussion below for reasons why and how to prevent it happening.

Reasons why blisters occur:

How to Prevent Blisters Occurring:

1. All water retaining structures should have a waterproof membrane on the outside and underside as a matter of course. This is not always specified or indeed carried out, leading to the issues seen in the images above.
2. It is often acceptable to have a waterproof membrane on the inside of the water containing vessel, providing it is designed as a negative pressure coating. (meaning used on the inside)
3. A high build epoxy (300 microns dft, plus) when applied to a correctly prepared surface, will usually be successful in resisting these issues, within reason. Though a proper WPM in #2 is preferred.
