## INFO SHEET

### Rust stains and pool resurfacing

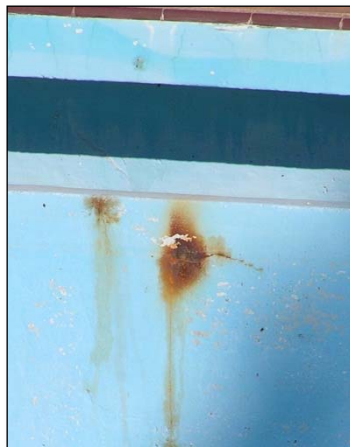
Crack with rust stains.

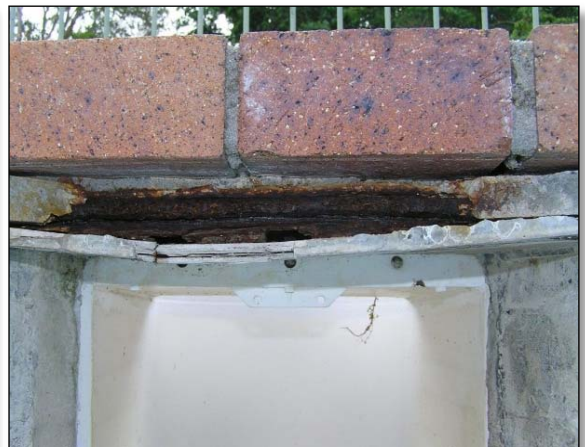
Check the metal plate above skimmer box

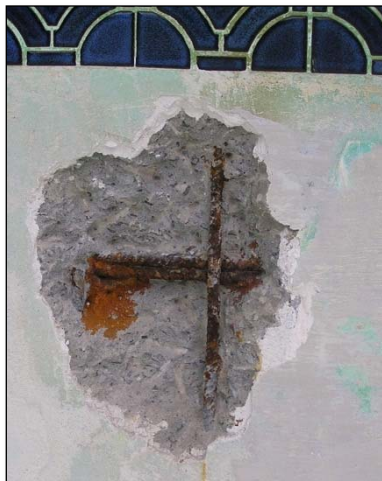
What you may see once you start digging into the rust spot. On closer inspection it can be seen that the rust is all around the steel and the concrete needs to be **dug out completely and rusty steel exposed on ALL sides. This is vital for a successful result.**

The green arrows (right) indicate steel accessible ALL round.

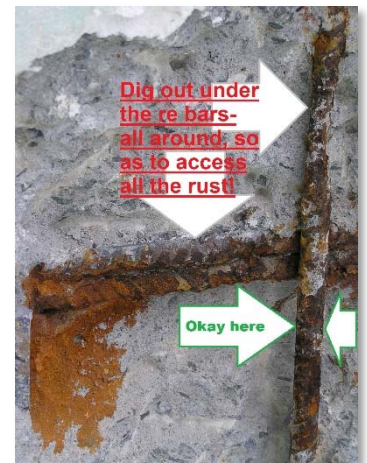
It's vital to dig all concrete away from rusted steel and expose it. Then wire brush all loose rust off. Once back to sound steel, apply an oil based anti-corrosive primer or a Kelate (rust converter). These are available from all good paint shops.

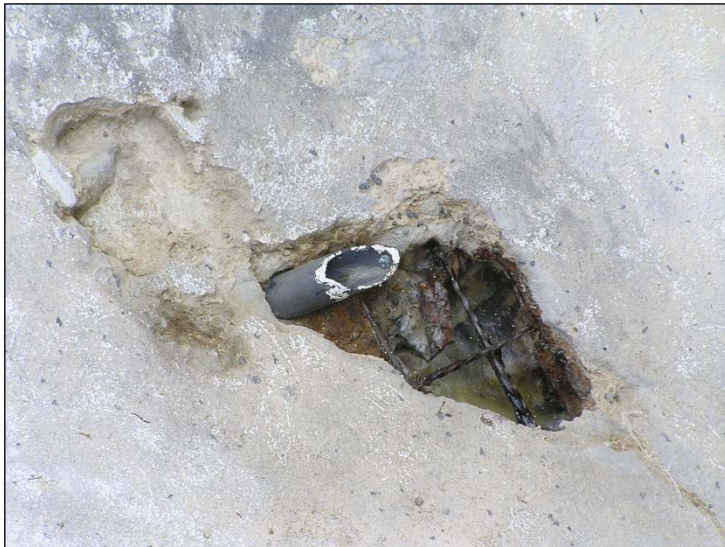
Then refill voids with a sand cement mix. It may require 2 or 3+ applications 20 – 30 mm thick, to build back to original surface. To prevent shrinkage, use a 3 : 1 washed sand to cement mix

(or a proprietary mix) and cure correctly by keeping moist for several days in hot weather. You can smooth off the final surface to match adjoining areas.

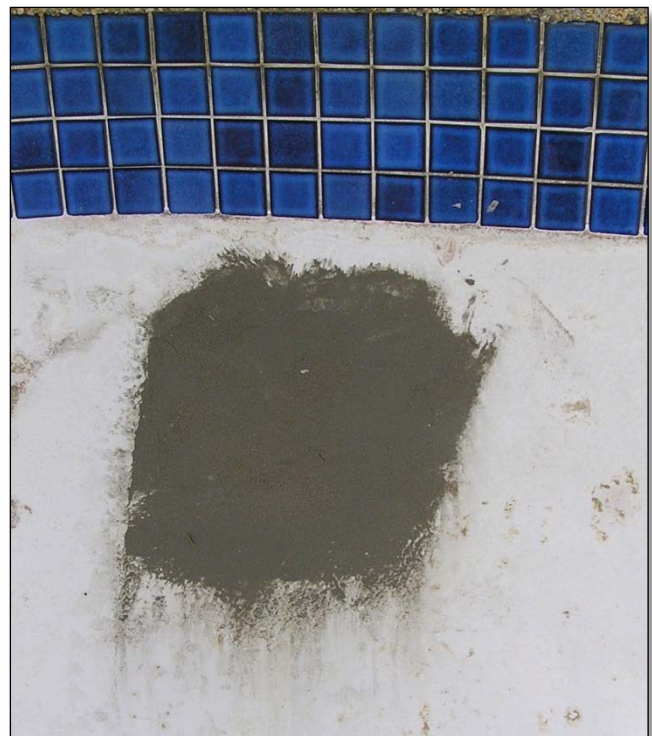
The finished surface which now blends in with nearby areas, is ready for coating with PaintnForget
