## INFO SHEET

### Discussion about Coatings and Hydrostatic Pressure

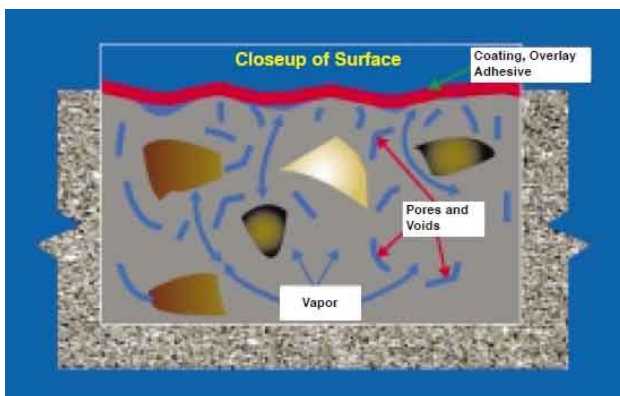
Figure 1 Voids in concrete provide space for condensation

**What causes the Water Vapour to move within concrete?** As gases can change shape they can wiggle through tiny voids as small as 5 micrometers. The gas is harmless to the concrete, however when it condenses into water it takes on a much bigger size. As the concrete cools (such as in winter - pool water cools) its ability to keep the water vapour in a gaseous phase diminishes and it condenses into liquid. This “new” water will have a pH of 7 which allows it to attack other molecules in the voids including weak cement ions and this continues enlarging the void. Over time the destructive effect grows, and other molecules previously bound to the now missing cement molecules, are affected. When these voids are near the surface of the concrete, large voids cause the de bonding of the surface of the concrete and any coating attached to it. Also, when vapour turns into liquid, another force is created called capillary action. The “new” water is attracted more to the surrounding surfaces (inside of voids) than to itself. Meaning it can move around both vertically and horizontally within the pores and capillaries in the concrete. As this water gets near the outer deteriorating concrete surfaces just below the coating, it will often force the coating to blister or bubble just before final delamination.

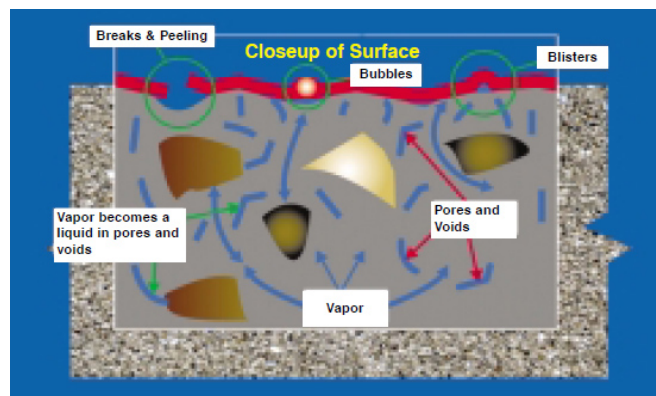
Figure 2 A void near the surface can lead to de bonding

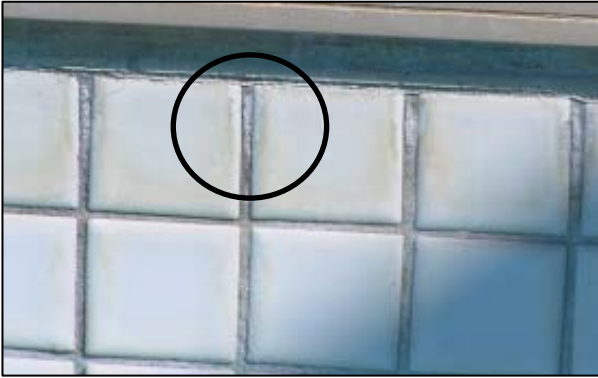
**Figure 3 Showing telltale efflorescence on tile grout indicating water passing out from pool shell.**

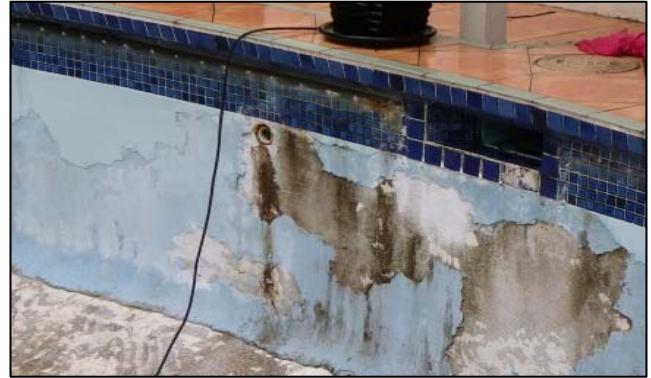
**Figure 4 Effects of poor drainage around pool and causing in part delamination of render.**

**Other related causes:** These can be from rain runoff, such as when water absorbed into the soil near the pool and runs past, under or around the pool and in so doing saturates the pool structure. This can be seen on pools on hillsides and near to buildings where the collection of water from nearby areas is channeled to areas around the pool. Pathways, patios and lawns near pools are also ways to generate large areas that saturate ground with rain runoff, causing the pool to get “wet feet.” Sometimes we find leaking plumbing can also be a cause, especially if blisters are near outlets below the water line.

Or one may leave the pool and see if there are other ways to direct the rain or water away from the pool. Such as making sure rain is not directed anywhere near the pool or if it is, adding drainage nearby so it can escape quickly, before saturating the soil near the pool.

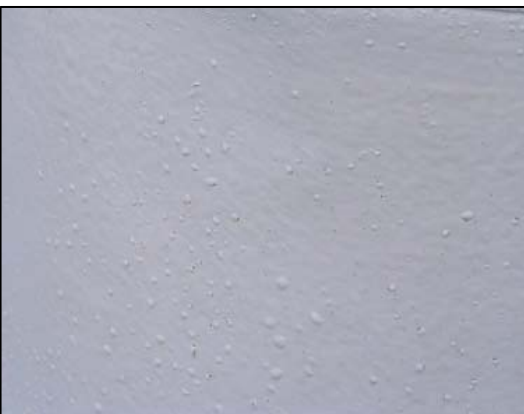
**Figure 5 Painted wall showing hydrostatic blisters**

**What do you see?** Fortunately, in our experience it's not a common problem as most pools are well constructed and in dry areas. Often in pools painted with thick coatings, if there is to be an issue with this, it will show up after some time. (Months to years) The exception is when heavy rain has occurred soon after application and the ground is wet. (higher water table). Also, more often than not it will be seen first on pool walls that face North to Northwest (Heated by sun generating higher temperatures and causing more water vapour activity within the walls). It may also happen on other walls if they have areas of porosity within, including cold concrete – render joints.

To check, drop the water level enough to expose some blisters. Carefully pry it open with a sharp knife. If water comes out (maybe dark in colour) it confirms hydrostatic pressure is the cause.
