INFO SHEET

Pools On Hill Sides or Close to Homes

Issues to be aware of:

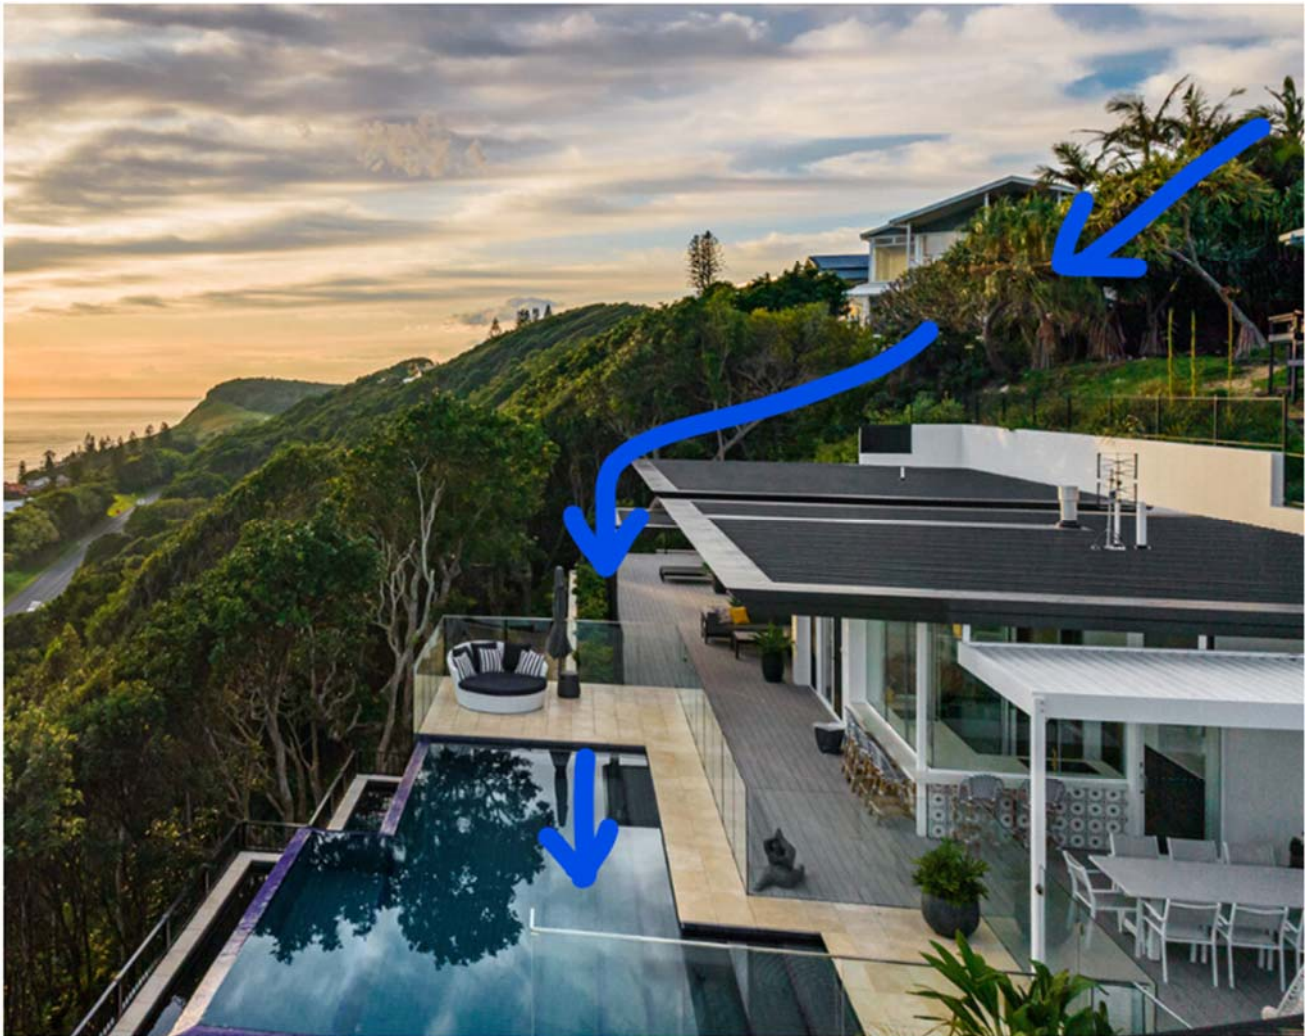
An example of a pool close to a home and potential cool air flowing down hill and into the pool.

Where there is any pool close to a house (like less than 20 metres), there is always the prospect of cool night air flowing OFF the roof and into the pool. It may end up at the deep end or if enough fill the whole pool, till morning sun heats it up. Such air has high humidity, and this can create an unexpected issue with partially cured paint. If the ground temperature is also low, less than 10C and even though you finished painting say at midday, the coating is not cured enough to resist the effects of this high humidity, low temperature air, overnight. In the morning you may find the surface partly white (Blushed) because of the effects of the overnight conditions. It may affect all the pool or some parts like the deep end only. Even if no effect, when the pool water is added a week or so later, it may turn white then, as the coating curing mechanism was interrupted by this situation, and it then is affected by full immersion in pool water.

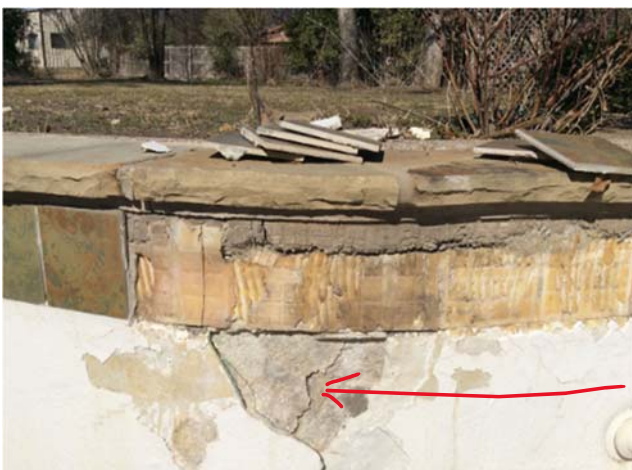
Here's a good example of all that is NOT good!

Structural crack in pool

Hopefully when you come to see the pool after it's been in the location for 20 years plus, it's still in a stable state. And thus, you can assume all is good. However, do look around for cracks, uneven pathways, subsiding banks and similar. Whilst you are not an "engineer" you should seek to be sure there are no obvious issues or indications of pending issues, for the sake of your reputation. If in doubt, ask the owner to get a professional engineer to investigate. And lastly tag your quote – contract that you are not an engineer and have no liability for any structural defects, seen or unseen.
