INFO SHEET

Testing Pool Surfaces for Moisture – Black Plastic Sheet Test ASTM -D – 4263

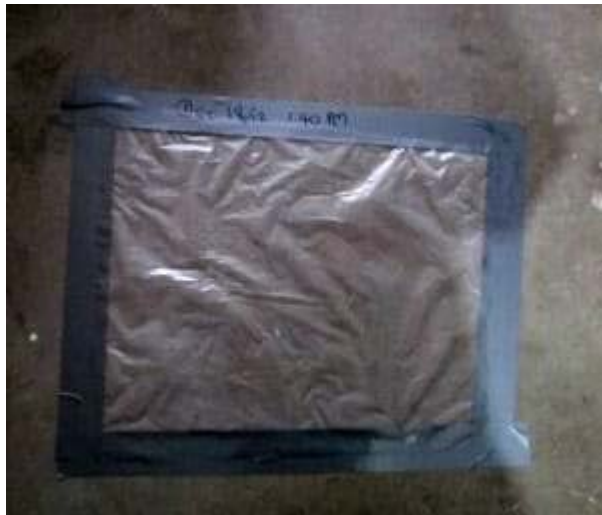
A simple test to see if water – moisture is an issue is this test. If in doubt, make use of it.

3. Usually include 4 – 6 test sites that include the deep end, the shallow end and any from #'s 1 and 2.
4. With heavy duty black plastic (Bunnings etc) cut into 400mm x 400 mm squares.

5. To a “dry” surface apply the black plastic and seal securely ALL the way around with a heavy-duty tape to make sure no water – moisture leakage. (If need be, with a rough surface make extra wide taping).

6. Allow to stay in place for 24 plus hours and with no rain!
7. Return and peel up gently looking for any moisture droplets on the underside. (And or a dark colouration on the concrete surface beneath)
