## Osmosis in Fibreglass Pools:

### A Plain-English Guide for Australian Pool Owners

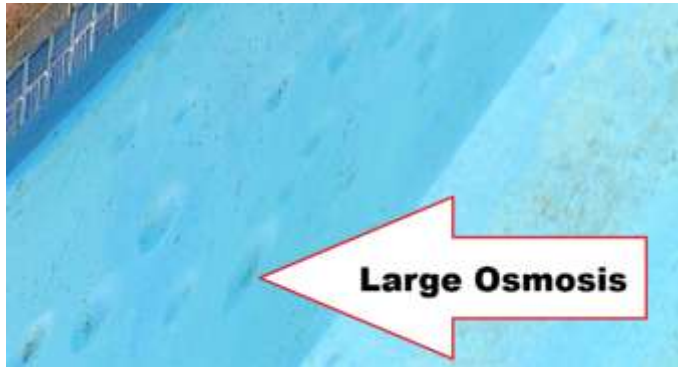
For many pool owners, osmosis first appears as small bubbles, blisters, black spots, raised lumps, or weeping marks on the pool surface.

The important thing to understand is this: **osmosis is not just a surface stain. It is a moisture-related breakdown process inside the fibreglass structure.**

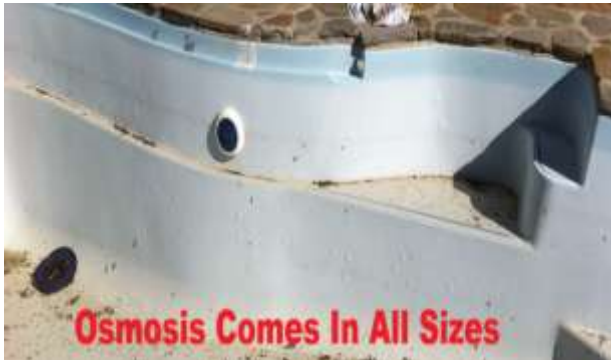
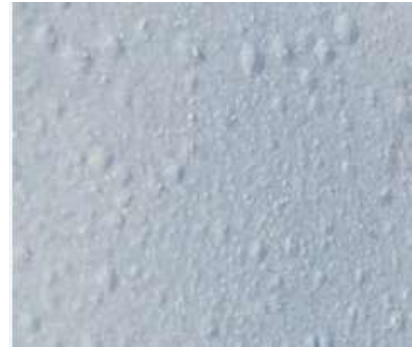
- Less chemically resistant gelcoats
- Resin systems more prone to water absorption
- Poorer cure control during manufacture
- Air voids or dry areas in the laminate
- Less consistent quality control
- Decades of exposure to water chemistry swings

Modern fibreglass pool manufacturing has improved significantly, especially with better vinyl ester barrier layers, improved gelcoats, better moulding practices, and tighter quality control. That said, no fibreglass pool is completely immune if the laminate, surface, or water conditions are poor enough over time.

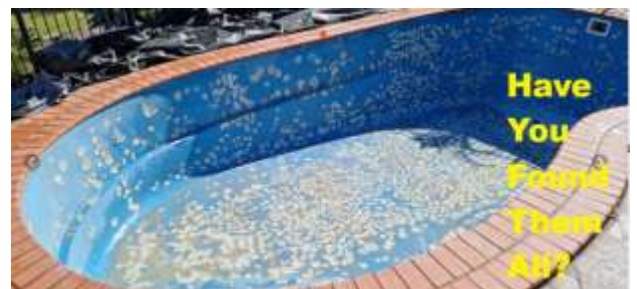
Osmosis can appear in several ways, including:

- Small raised bubbles or pimples
- Larger blisters under the gelcoat
- Black or dark spots
- Small craters after blisters break
- Weeping marks or discoloured spots
- Rough patches where the surface has failed
- Groups of defects in certain areas of the pool

Sometimes only a few spots are visible. However, what you see on the surface may only be the defects that have finally reached the outside. More moisture activity may still be developing deeper in the laminate, out of sight.

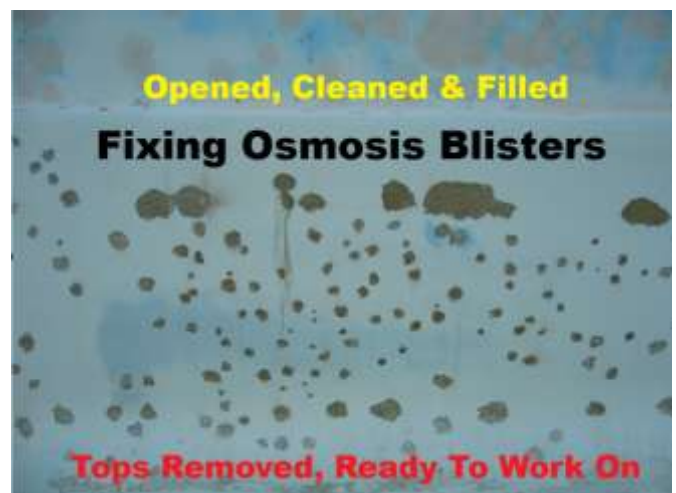
For small numbers of blisters, a practical repair may include:

- Draining the pool
- Grinding or cutting out the blister
- Washing and drying the area
- Filling with epoxy filler
- Sanding smooth
- Painting or coating the repaired area

This can improve appearance and slow local deterioration, but it should be seen as a **patch repair**, not a full cure.
