INFO SHEET

Discussion about Marblesheen pools and upgrading with a Hi Performance Coating.

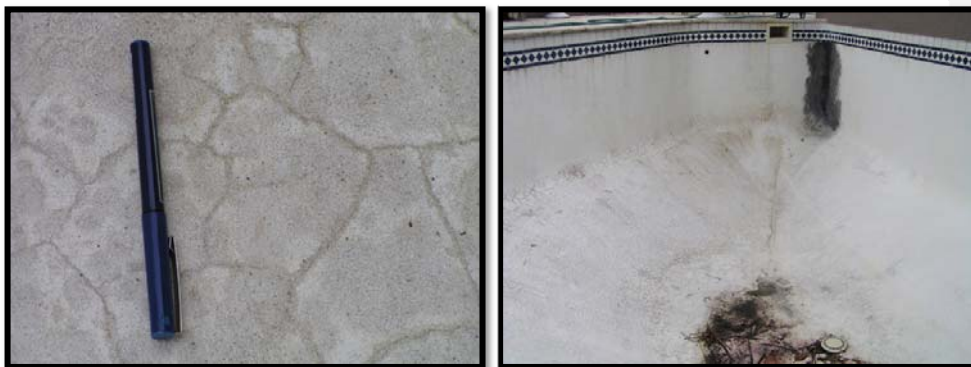
Over the years and depending on the quality of installation, pool water chemical balance and general wear and tear, it will slowly degrade. Usually is ends up with random cracks, worn areas, black staining and may be rust staining too. There can be large areas where the Marblesheen is soft and weak. Some areas may be drummy (hollow underneath) or break away completely. There may be white calcium build ups as well.

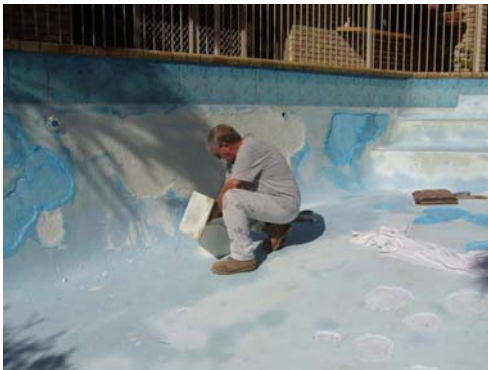
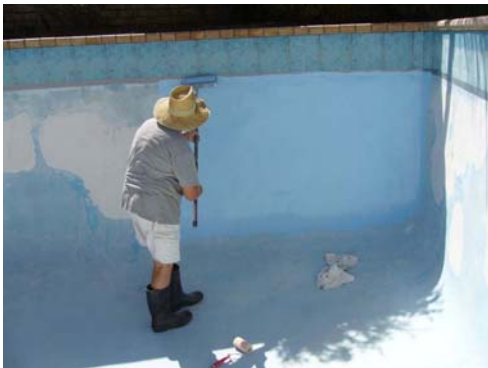
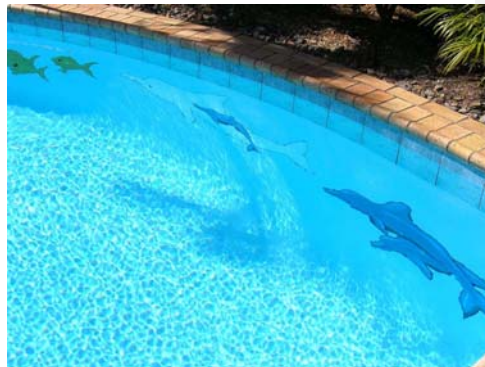
Undertaking repairs to Marblesheen, through to finished pool.

- Empty pool and look closely at surface.
- Check for drummy and soft / weak areas – remove & replace.
- Check for rust spots and if from below, deal with corrosion of pool structural steel work thoroughly.
- Algae roots need to be killed with algacide
- Calcium residues need to be removed.
- Any missing, worn or rough areas should be filled before painting.
- A thorough clean to remove all fats, dirt and loose particles.
- Apply 1 – 2 coats of a sealer coat
- Apply 1 coat of a bodycoat.
- Apply 2 coats of PaintnForget for a seamless, easy clean, long-lasting finish.
