INFO SHEET

Pool Paint Defect Pictures

Some common issues with pool painting.

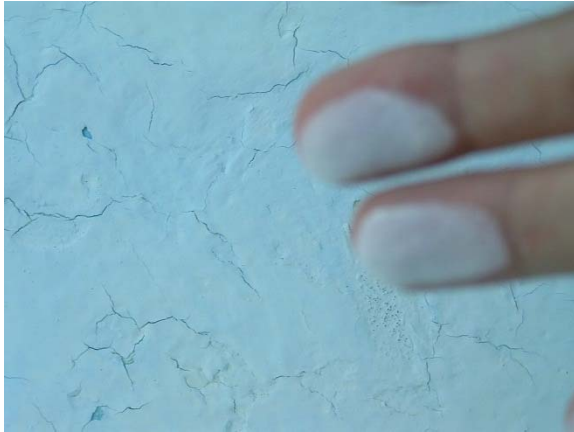
Fig 1: Paint can become chalky over time and leaves a film on your figures. This happens sooner with Chlorinated Rubber (1 – 2 yrs) and takes much longer with Epoxies. (5 -8 yrs) and for a MUCH longer life, (PaintnForget), which does not chalk. It may also be quite often the result of insoluble residues in your pool. Need to check which.

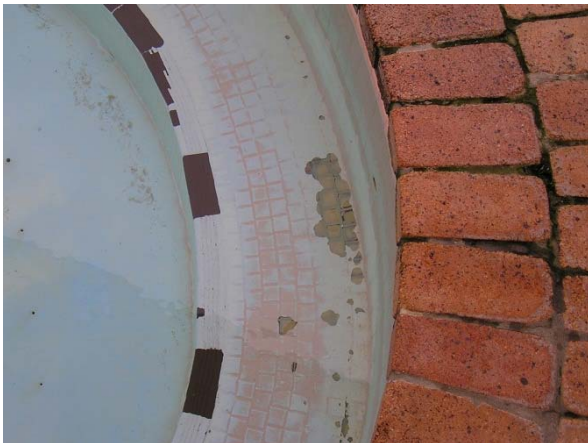
Fig2: (right) Painting of tiles is not recommended as it can lead to failure of the coating at the edges.

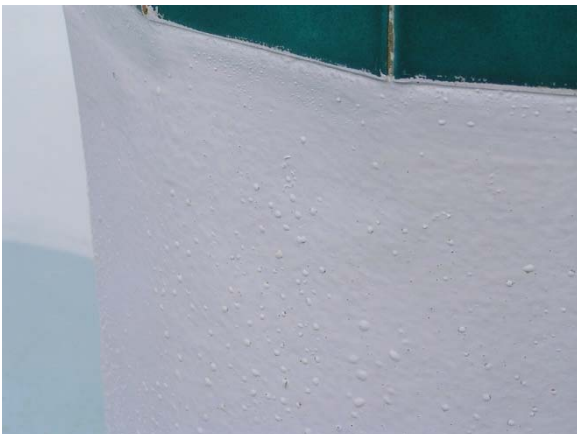
Fig 3: (below left) Blisters in a painted wall due to hydrostatic pressure of ground water rising up inside the concrete and being drawn to the surface, forming blisters.

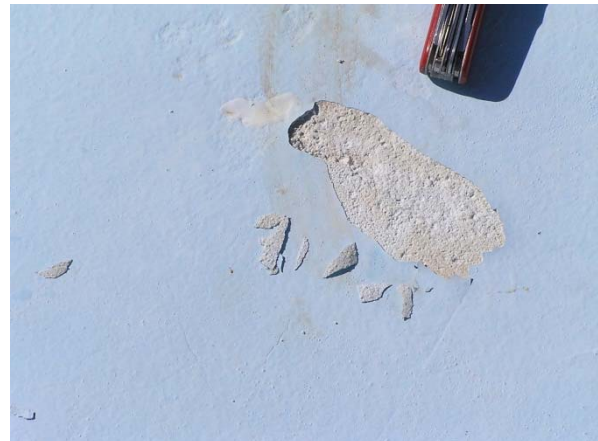
Fig 4: (above) The substrate failing internally and coming away, bringing the paint with it. Often due to hydrostatic pressure beneath and coming through the concrete shell.
